Issue Number:	<b>N172404</b>	PDF Date Submitted	01/07/2005

<input checked="" type="checkbox"/> Part - Location:	<b>Ignition Key Cylinder Assembly -Column - Steering</b>				
<input checked="" type="checkbox"/> Complaint:	<b>vehicle can be keyed off with knee while driving</b>				
Issue Type:	<b>Current Prod</b>	Vehicle/Product Line:	<b>3Acar</b>		Region:
<input checked="" type="checkbox"/> Severity:	<b>3</b>	Primary Metric/Score:	<b>LaunchX / 0.025</b>

## GMX001 Lock Module Detent in RUN

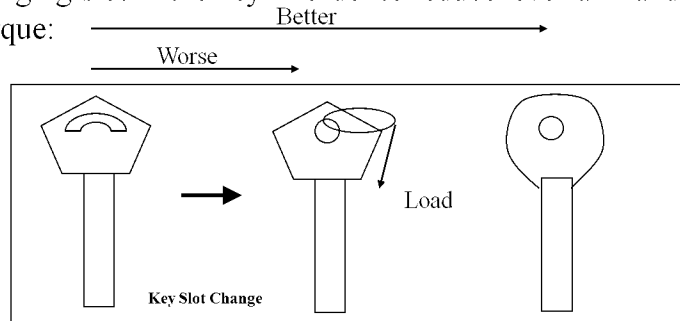
➤ Changing slot in the key in order to reduce lever arm and thus the torque:

✓ It was determined that the lever arm is still present due to fob ring. This may even cause a higher pulling load if fob ring is wedged between the slot and the sharp corner of key.

✓ Can be considered as a containment if the shape of key is changed to round corners
